New Hampshire Volunteer Lake Assessment Program

2002 Interim Report for Todd Lake Newbury

NHDES Water Division Watershed Management Bureau 6 Hazen Drive Concord, NH 03301

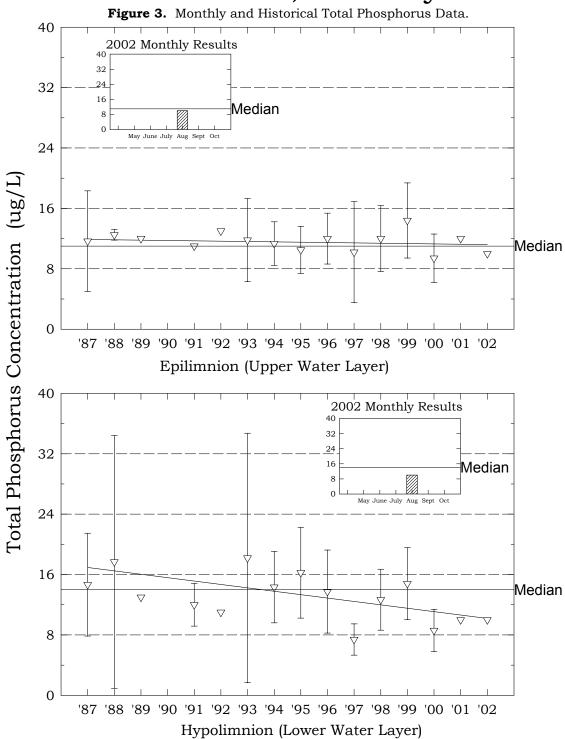
Figure 3 and Table 8: The graphs in Figure 3 (Appendix A) show the amounts of phosphorus in the epilimnion (the upper layer) and the hypolimnion (the lower layer); the inset graphs show current year data. Table 8 (Appendix B) lists the annual maximum, minimum, and median concentration for each deep spot layer and each tributary since the lake/pond has joined the program.

The current year data for the epilimnion (the top inset graph) and the hypolimnion (the bottom inset graph) show that the total phosphorus concentration in August was **slightly less than** the state median.

Overall, visual inspection of the historical data trend line for the epilimnion (the upper graph) shows **a relatively stable** total phosphorus trend, which means that the concentration has **remained approximately the same** since monitoring began in 1987.

Overall, visual inspection of the historical data trend for the hypolimnion (the lower graph) shows *a variable (meaning fluctuating)* total phosphorus trend.

One of the most important approaches to reducing phosphorus loading to a waterbody is to continually educate watershed residents about its sources and how excessive amounts can adversely impact the ecology and value of lakes and ponds. Phosphorus sources within a lake or pond's watershed typically include septic systems, animal waste, lawn fertilizer, road and construction erosion, and natural wetlands. If you would like to educate watershed residents about how they can help to reduce phosphorus loading into the lake/pond, please contact the VLAP Coordinator.
